# Case Study

## Ravensroost, Upper Norwood

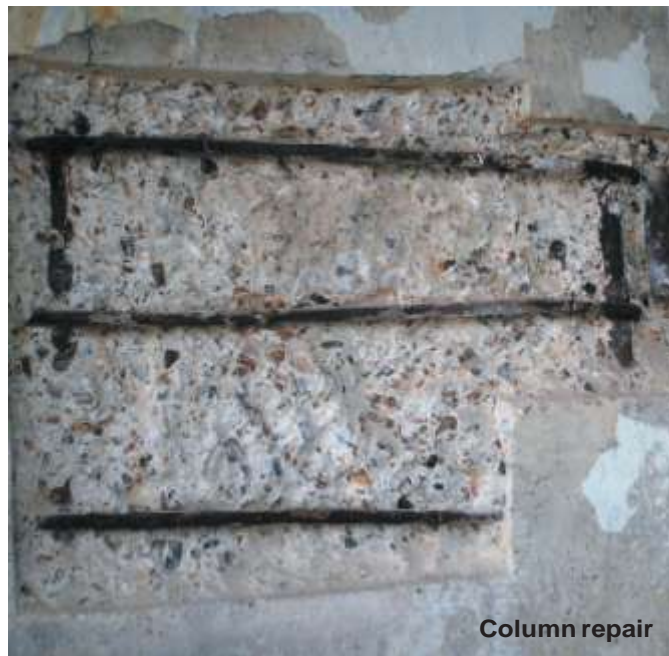
In this instance, the first area undertaken was the laundry area, and following a survey and extensive hammer testing to all soffit areas by Cemplas operatives, the laundry area was found to have many defective and spalled areas of concrete. The remedial measures proposed by Cemplas were to carry out to determine the extent of repairs. The soffit was jet washed, concrete repairs were undertaken

measures proposed by Cemplas were to carry out to determine the extent of repairs. The soffit was jet washed, concrete repairs were undertaken

and two full coats of coats of anti-carbonation coatings was applied to provide a decorative and protective finish.
