# Case Study

## Ravensroost, Upper Norwood

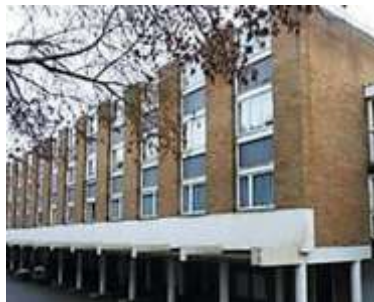
In this instance, the first area undertaken was the laundry area, and following a survey and extensive hammer testing to all soffit areas by Cemplas operatives, the laundry area was found to have many defective and spalled areas of concrete. The remedial measures proposed by Cemplas were to carry out to determine the extent of repairs. The soffit was jet washed, concrete repairs were undertaken

and two full coats of coats of anti-carbonation coatings was applied to provide a decorative and protective finish.
