**Press Release**  
**August 3<sup>rd</sup> 2015**

## **Windermere Court**

***The Richmond Housing Partnership Group, which owns or manages more than 10,000 homes in Richmond and Hounslow, contacted Cemplas Waterproofing and Concrete Repairs Ltd to undertake a survey and provide a remedial specification and quotation to undertake repairs and specialist coatings to four staircases at one of its properties in SW13.***

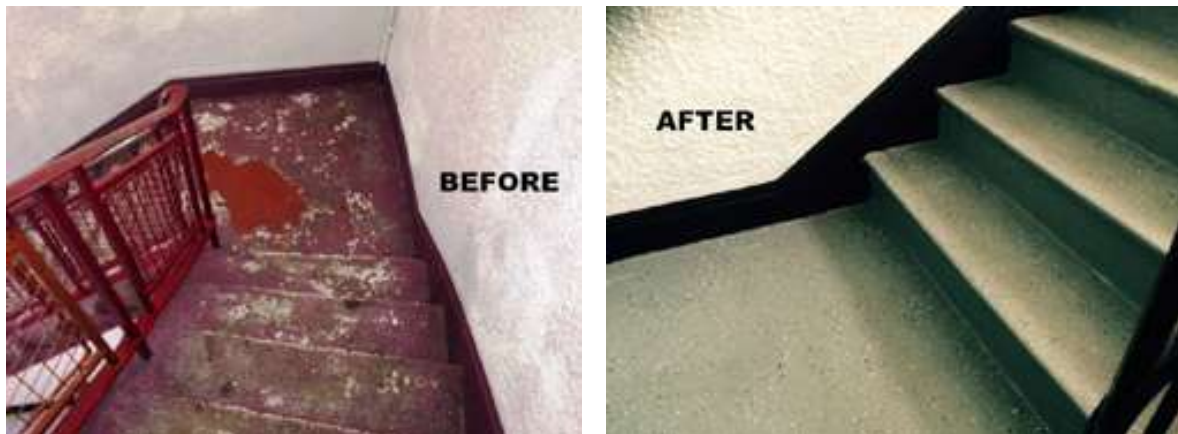
Work commenced with grinders and planing equipment to remove all existing floor coatings to the landing areas, treads, risers and upstands. Once all the floor coatings had been removed, operatives dealt with areas of cracking and spalling to the concrete substrate.

Once the floor had been fully prepared, and repairs had cured, Cemplas proceeded by applying Vulkem Quick Half-Flake Coloured Coating System. The system incorporates Vulkem Quick Primer, Vulkem Quick Membrane, Vulkem Quick Coloured Sealer with coloured flakes and sealed with Vulkem Quick Clear Sealer.

Once works were completed to the delight of the residents, and to the full satisfaction of the Richmond Housing Partnership, the resulting finish was an aesthetically pleasing, hard-wearing surface providing a much safer degree of access as the coating provides a degree of slip deterrent.
