## **Grandstand repaired with HB40 at Fakenham Racecourse**

*Repairs were required to the underside of the Grandstand at Fakenham Racecourse where steel reinforcement had corroded causing the concrete to spall.*

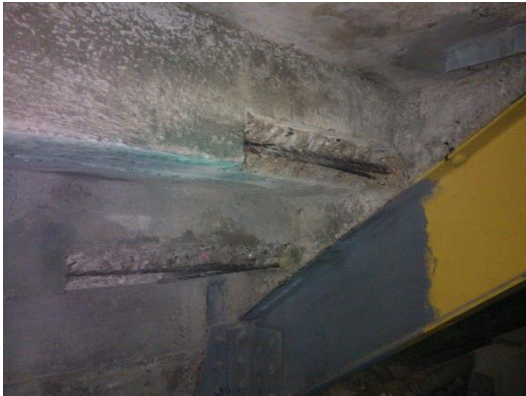
A prepared area after removal of spalled concrete and cleaning of the reinforcement

Ronacrete Approved Contractor Apolodor was contracted to carry out the repairs to the concrete structure. Apolodor broke out the damaged concrete fully exposing the steel and removed corrosion before treating the steel with **Ronacrete Standard Primer**. The concrete was repaired by application of **RonaBond HB40**.

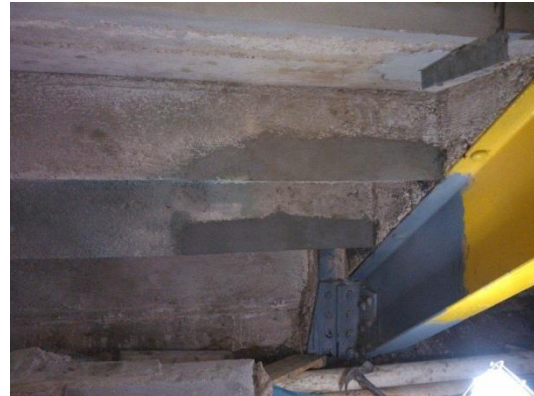
The same area after application of the repair mortar

**RonaBond HB40** is a pre-packed high build polymer modified concrete repair mortar. It is used to repair concrete on vertical surfaces and soffits. It is typically applied in layers up to 50mm thick on walls on walls and 30mm thick on soffits.
